Smoke and Dye Testing Summary

High Level Sewershed

Test ID	Test Type	Date Inspected	Company / Super.	Blower MH	Ground Condition	Notification Made?	Total Length
S1028-154	Smoke	4/13/2009	ADS/TM	S13A_007MH	Dry	Yes	1,936.82

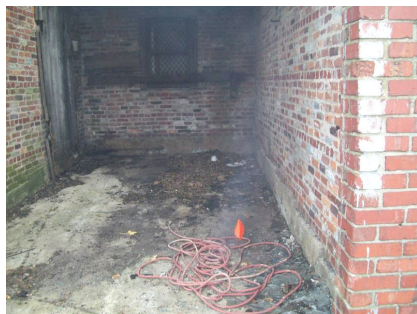
Picture \S1028-154-OB01-P01.jpg

Comments Smoke from cleanout in paved concrete area behind house. 2824 Rayner Avenue

Comments Back of house, 2824 Rayner Avenue

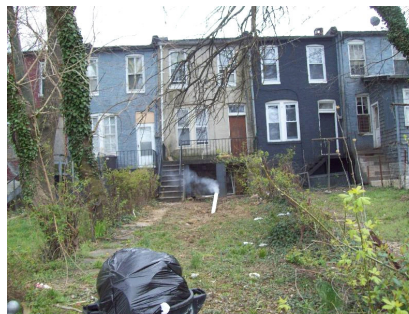
Picture \S1028-154-OB02-P01.jpg

Comments Smoke from cleanout in back yard. 2812 Rayner Avenue

Comments Back of house, 2812 Rayner Avenue
